TO: South Texas Water Authority Board of Directors  
FROM: Jose M Graveley, President  
DATE: October 7, 2025  
SUBJECT: Meeting Notice and Agenda for the South Texas Water Authority

RFP – 42” Waterline Condition Assessment

Project: 42" Bar-Wrapped Pipe (AWWA C303) – Mechanical Fitting Condition Assessment

## Section 1: 42" Pipeline Desktop Assessment - Review in Context of Previous Studies & ICE Recommendations

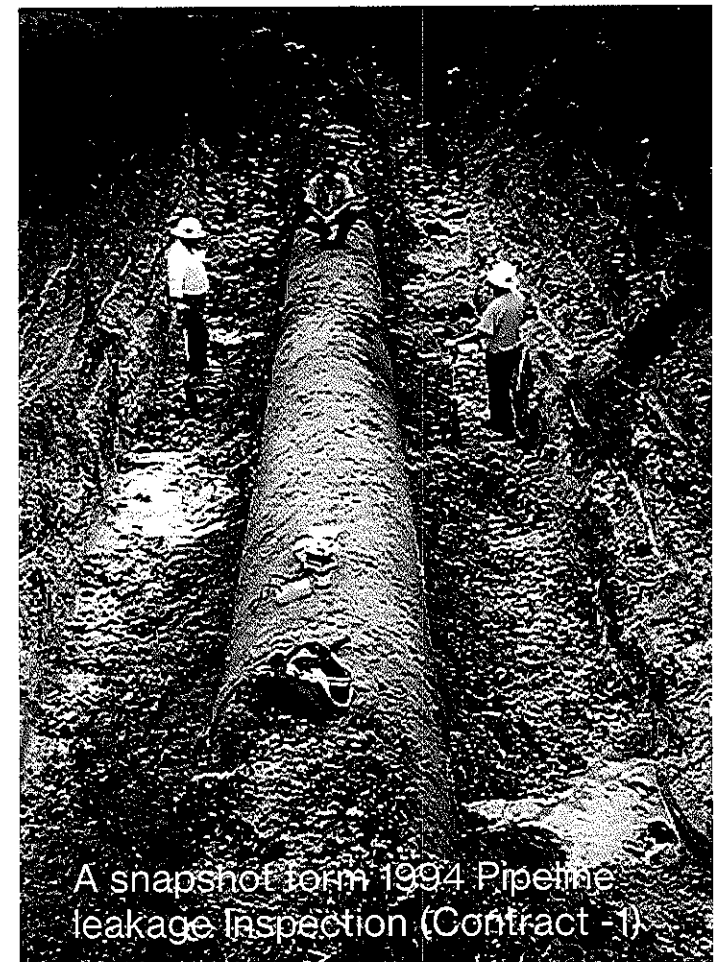
A snapshot from 1994 Pipeline leakage Inspection (Contract -1)

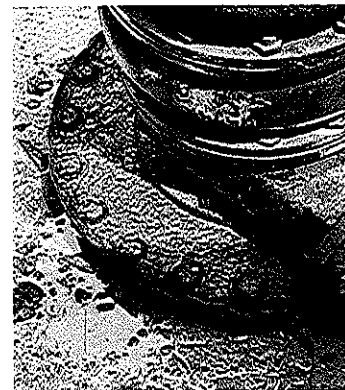
- Possible metal loss and cracking risks on ARV & Gate valves
- Pipeline surface corrosion due to aggressive soil.

Metal loss on ARV- 2025  
Inspection

- Resolve electrical discontinuity identified by Corpro (2020) before further cathodic protection
- Expand annual CIS Survey to Contracts 2 & 3 (only Contract 1 was surveyed in 2020)
- Assess all **mechanical components for repair & coating** failure risk.
- Plan: Inspect, clean/sandblast, and recoat per standards

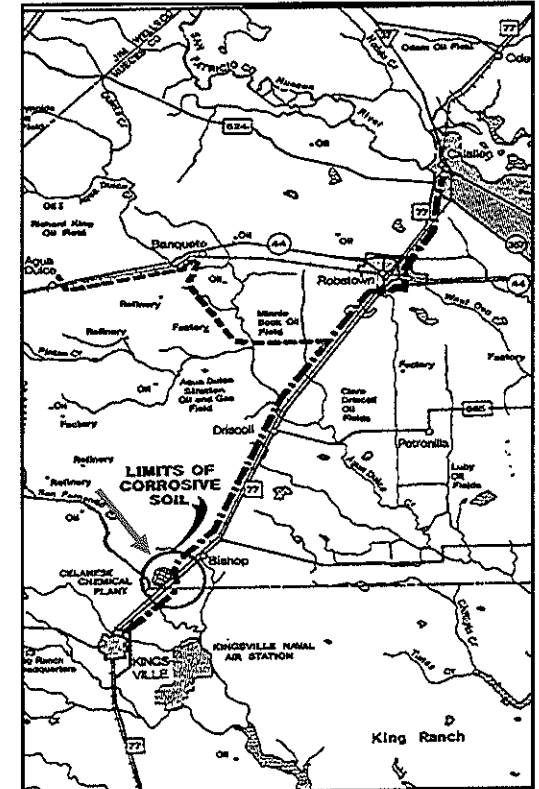
- High chance of external corrosion
- Identified highly corrosive soil between Kingsville and Bishop

Identified Corrosive Soil Area by Previous  
Study - 1984

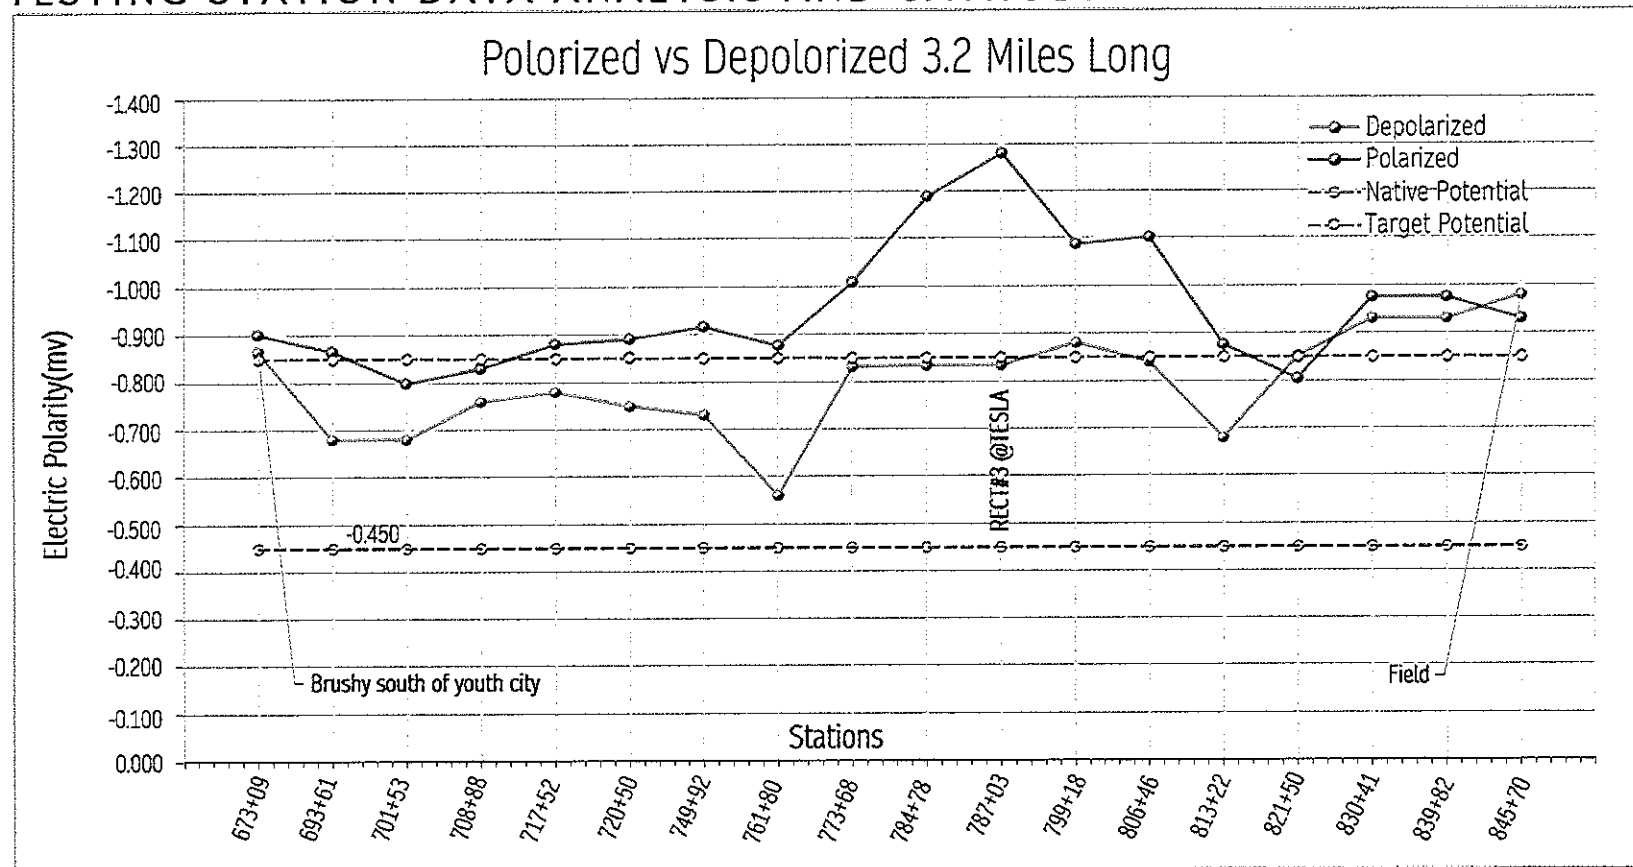
Note: Once the pipe potential reach -0.450mv(Native potential) corrosion begins at this point.

Figure 2. Test Station Results for 3.2 Miles Distance, Results from STWA CP team 2025 Inspection.

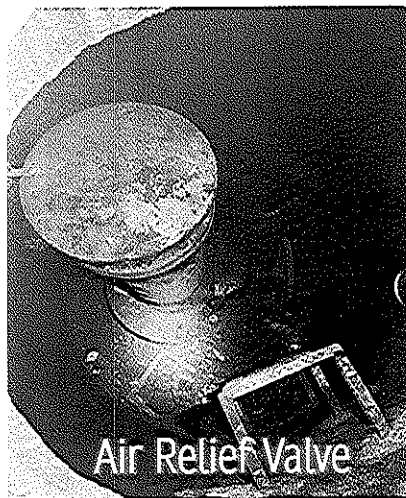
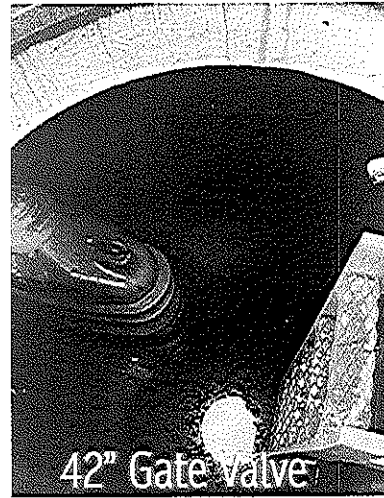
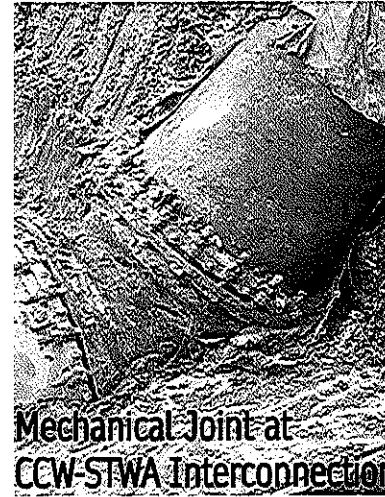
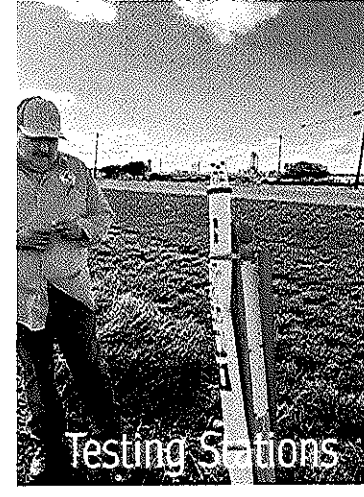
- Above Ground ARV Section: Over 15 units are in corroded condition.
- Block Valves: 5 valves (42") are submerged in water, with corroded joints.
- Mechanical Joints: Lack of protective coating, nuts and bolts are corroded condition
- The testing station require servicing and maintenance.

Recent ARV inspection images.

- Inspect and repair gate valves and air release valves (ARVs).
- Following these repairs, proceed with either a hydrostatic test or in-line inspection using a pipe diver, based on the chosen integrity plan.

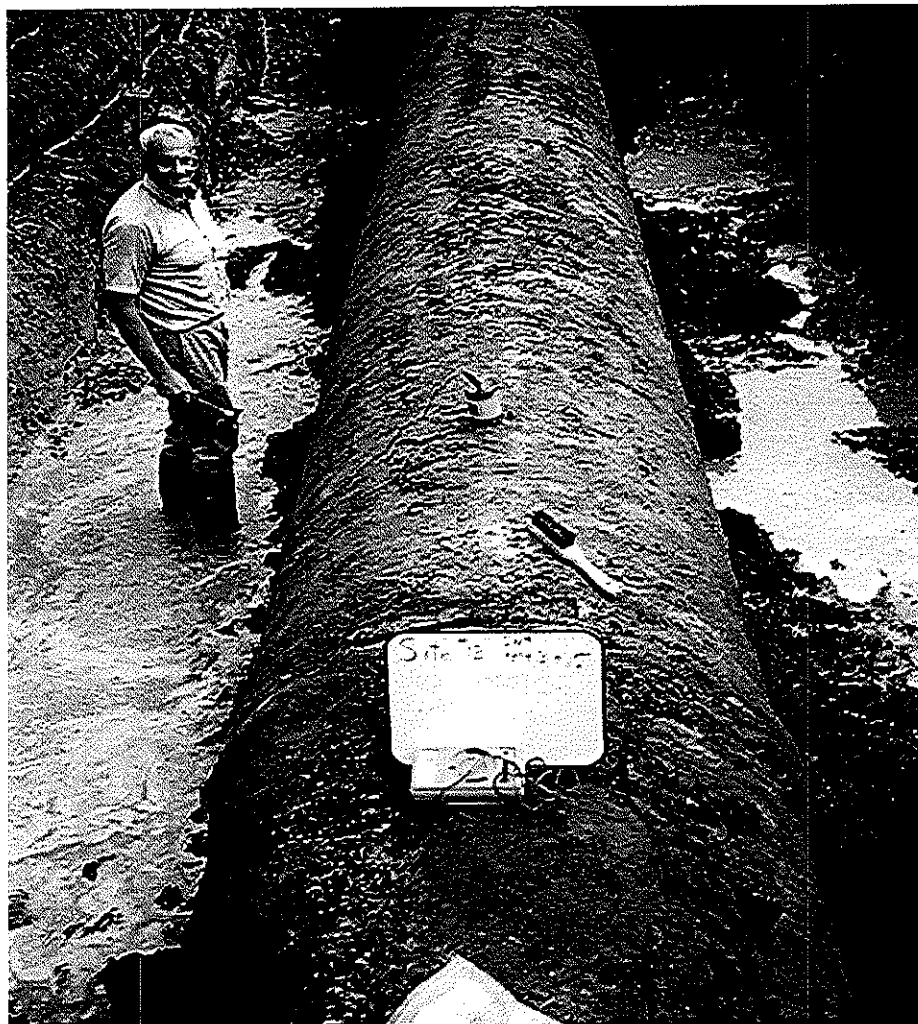
Figure 8. Excavation 11 - Pipe Joint Pitting.

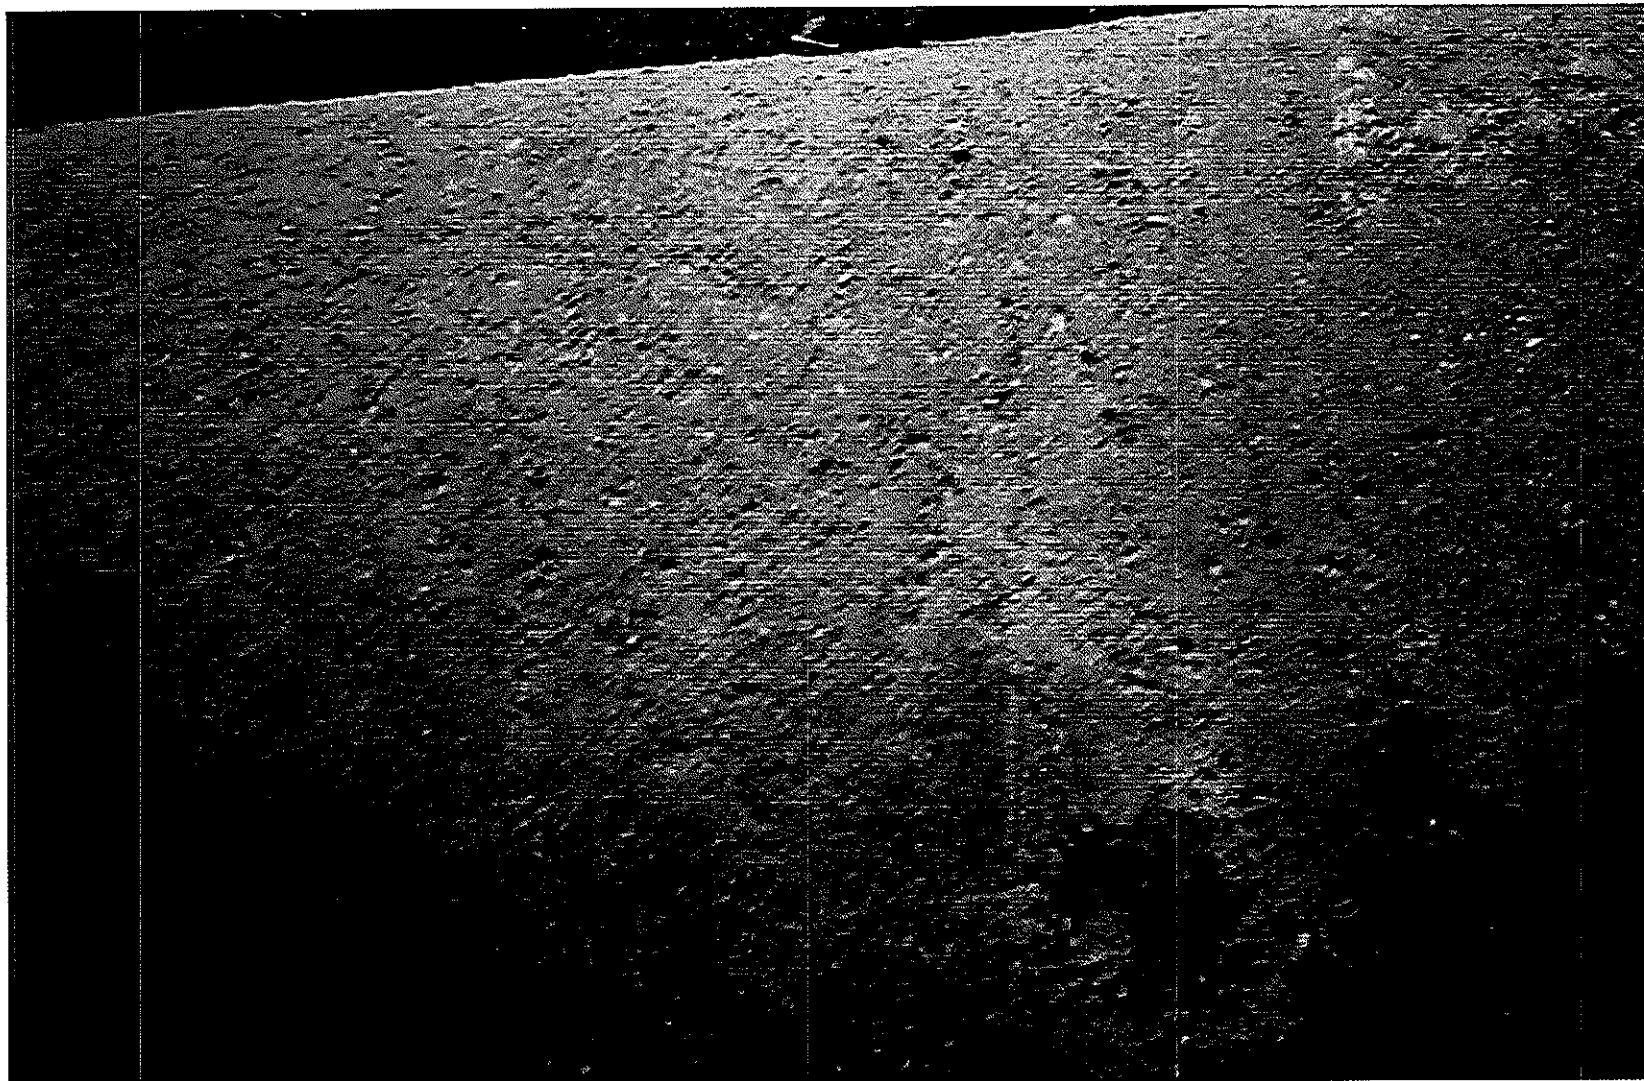
*Figure 10. Excavation 5 - Corroded Bar Wrap.*

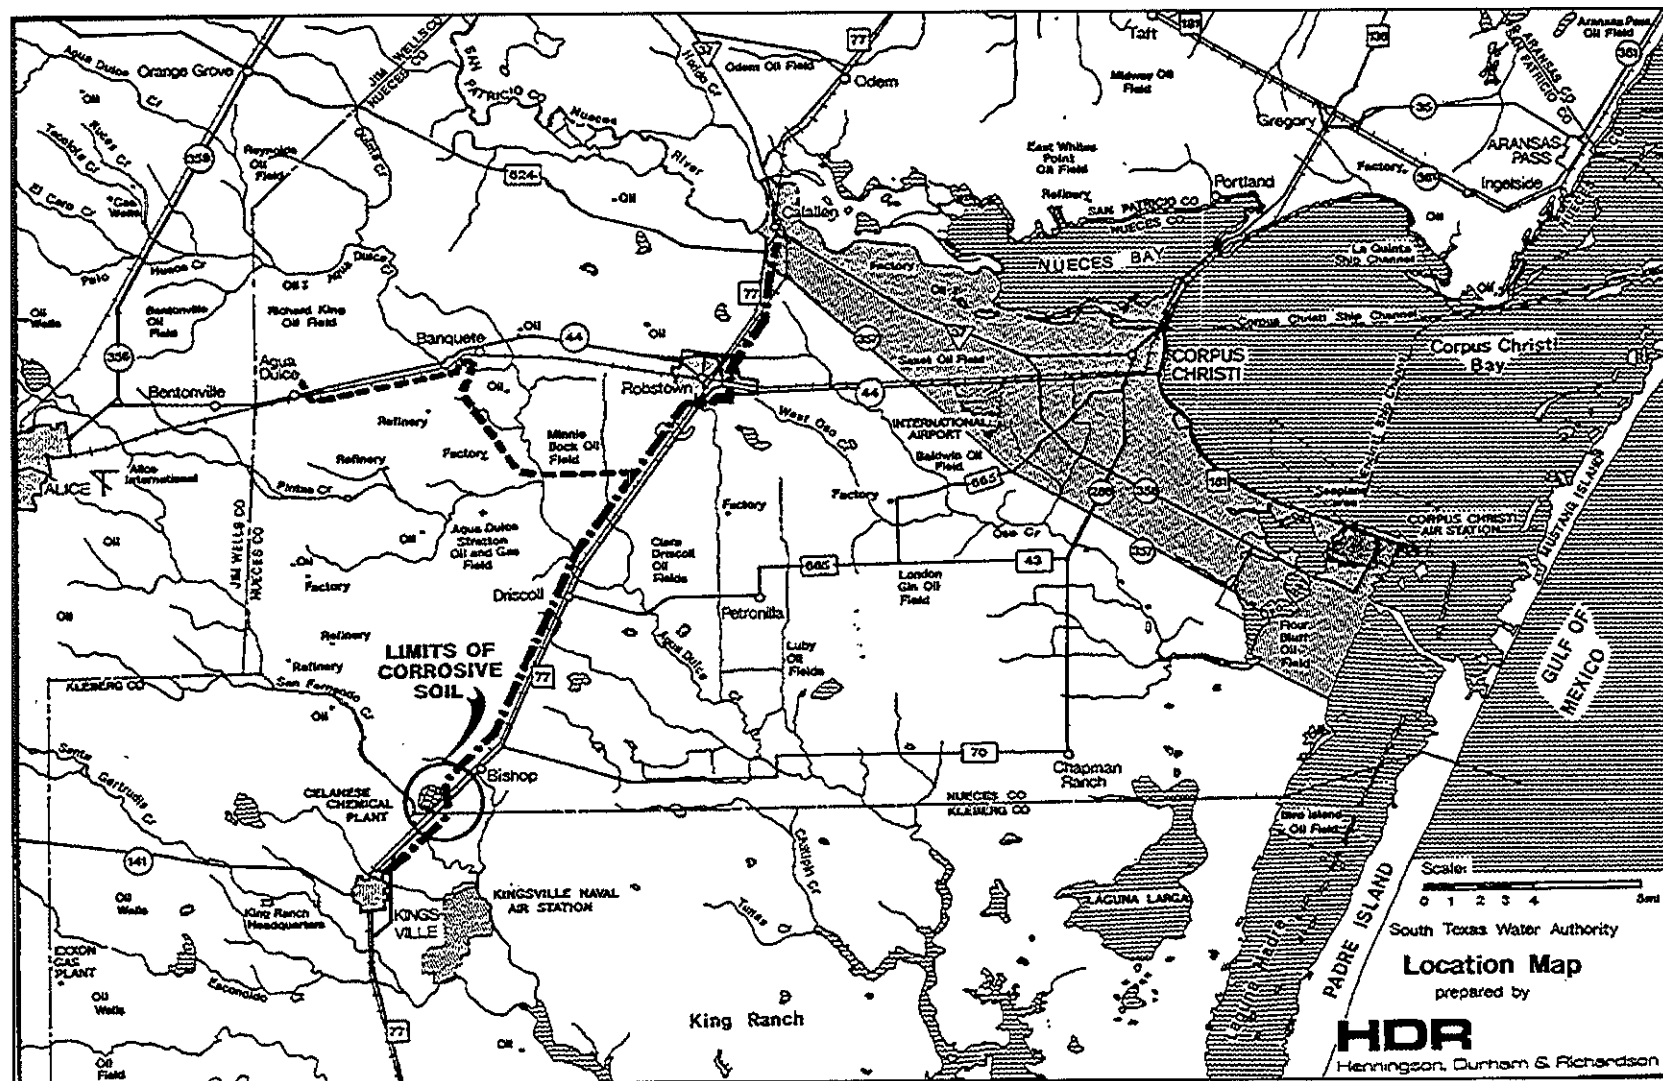
After the results were obtained, it was deemed necessary to increase the number of soil borings taken to extend the tested area beyond San Fernando Creek and Carreta Creek. The results of the soil analysis of these borings indicate the corrosive soils extend from San Fernando Creek north to Carreta Creek. This is approximately 16,500 LF or 3 miles.

Figure 18. Corrosive Soil Identified by HDR, 1984.

4. If the soil to pipe potential readings indicate galvanic action has started, then install a cathodic protection system to protect the steel cylinder from corrosion.
